Friends of Camp Zoe

at ECHO BLUFF STATE PARK

the STATE of CAMP ZOE LODGE JUNE 2016

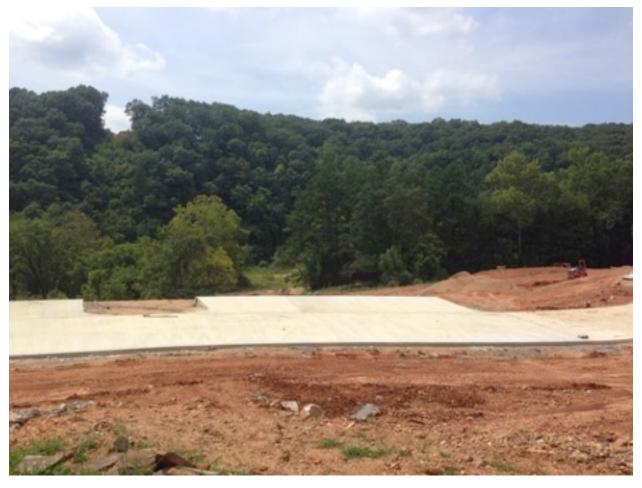
View from the new endpoint of the original walkway, showing the now-terraced slope that will feature the new bioswale.

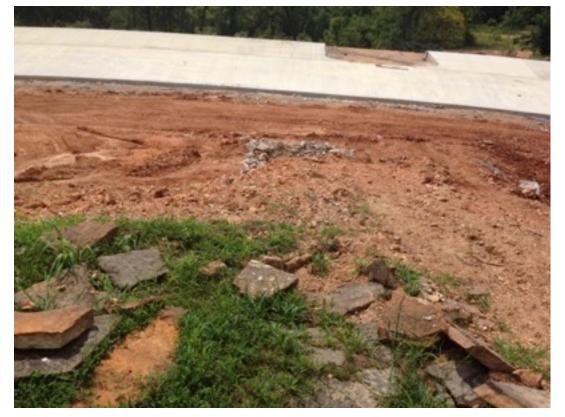
The new endpoint of the original walkway.

The loose stones will be re-used as pavers at the front of Camp Zoe Lodge.

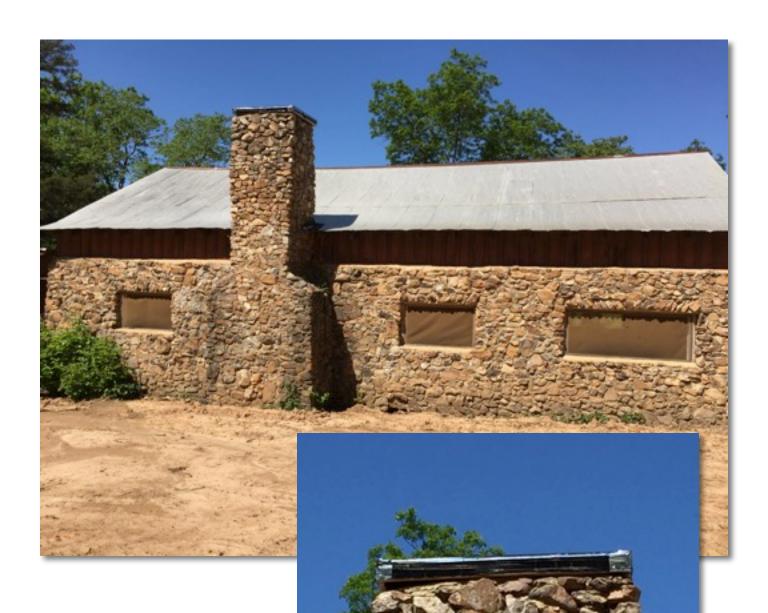
The temporary cap on the chimney to keep the rain from causing further damage.

There is still some dampness on the inside wall around the fireplace, so we need to get our work started quickly!

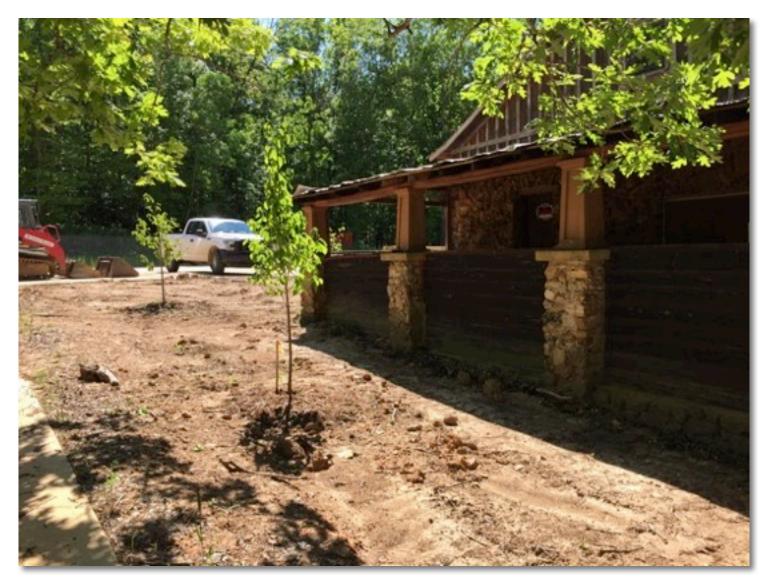
The above photo shows the additional grading that was done to move rainwater away from the building. There were also some new native Missouri trees planted.

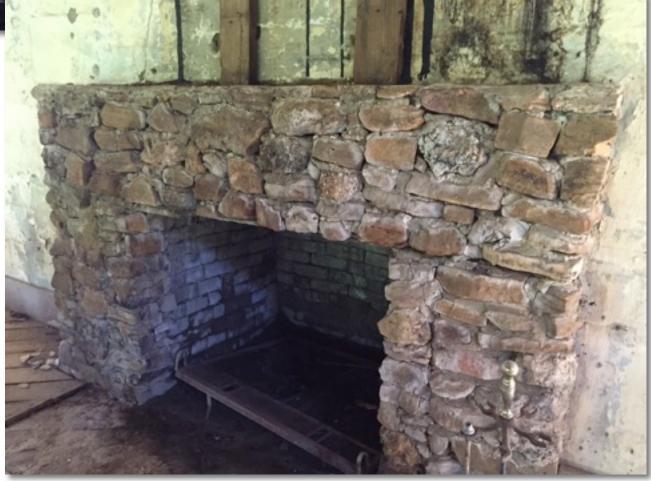
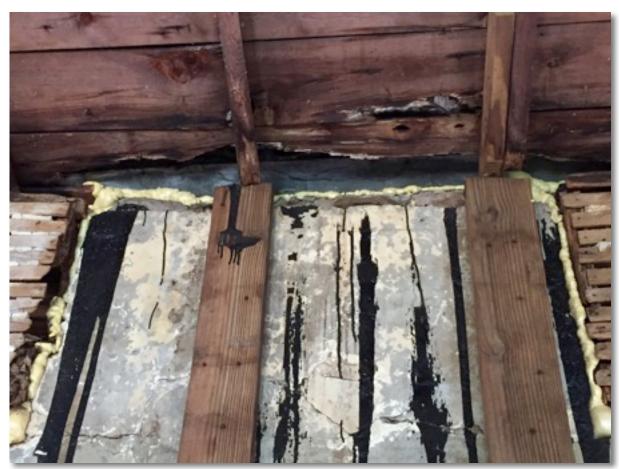
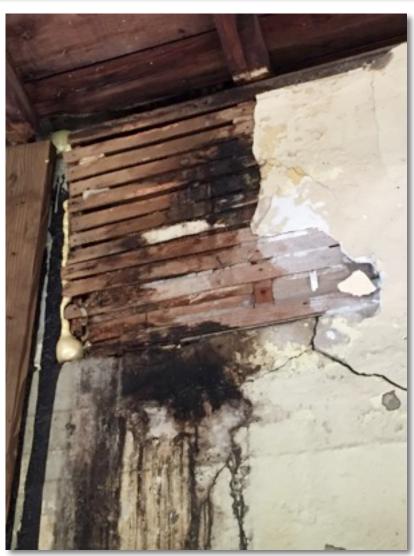
Many of the cracks in the interior walls, while alarming to see, are merely superficial,

However, some will require much more extensive repair, including the hole in the front wall where the previous owner installed a woodburning stove.

The hole in the roof from another stove chimney will be dealt with when the whole roof is repaired and resurfaced.

Most of the trusses are in good shape. Some are damaged and will need to be replaced.

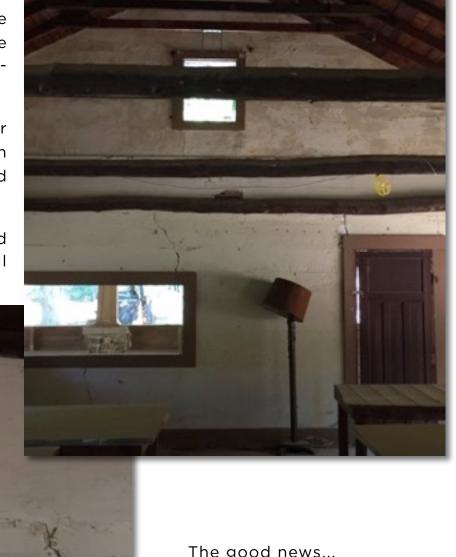
The good news...

All the original timber beams are in great shape and remain in place!
